Caterpillar Gas Engine Actuator Service Bulletin

All Woodward ProAct Digital Plus actuators on all Caterpillar G3500C/E (NG & Landfill) and G3520B (Petro) engines.

Separation of the electronics housing from the main actuator housing leading to loss of accurate position control and instability.

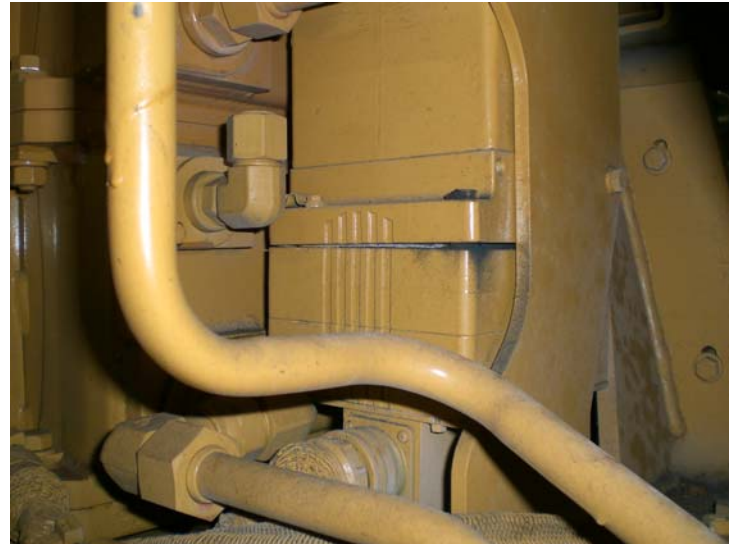
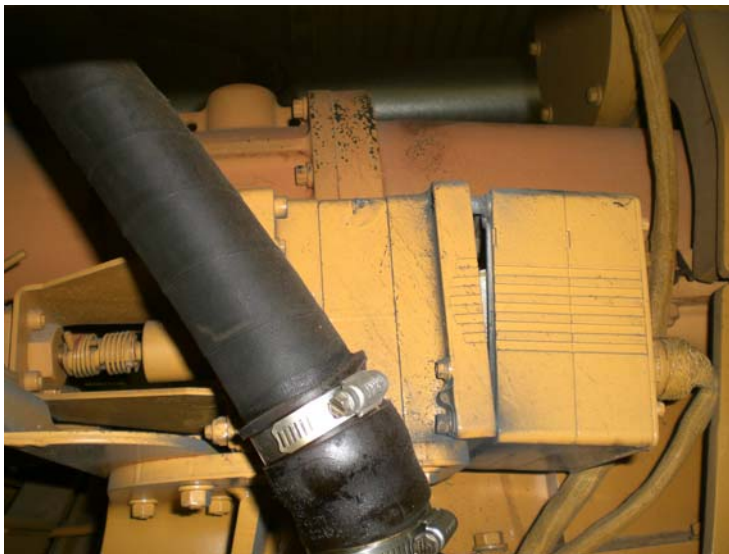
The ProAct actuators used for both the throttle valve and turbo compressor bypass valve on all Caterpillar G3500C, G3500E, and G3520B Petro engines have on-board electronic circuit boards. These boards are located in the aluminum housings on the back end of the actuator and are isolated from the main actuator housing to protect the electronics from engine vibration. Over time, the isolation system will break down and degrade to the point of failure. This is due to engine vibration and temperature levels generated by these engines that exceed the design intent of the actuators. See photos for examples.

Woodward has developed a new actuator, the ProAct ISC, that should be used in place of the original ProAct Digital Plus units. The design increases the actuator's robustness and ability to resist elevated temperature and vibration in these on-engine environments. The new actuator addresses the issue in three ways:

1. The electronics have been redesigned from two circuit boards down to one. As a result, the new actuator is physically shorter on the back end which reduces the amount of mass hanging on the isolation system.
2. The electrical connector has been changed eliminating the aluminum block on the actuator cover (throttle only). This also reduces the mass and strain on the isolation system.
3. The isolation system itself has been improved to include larger isolators and bushings
